10LU troubleshooting Optimus / *Velara* rotor control

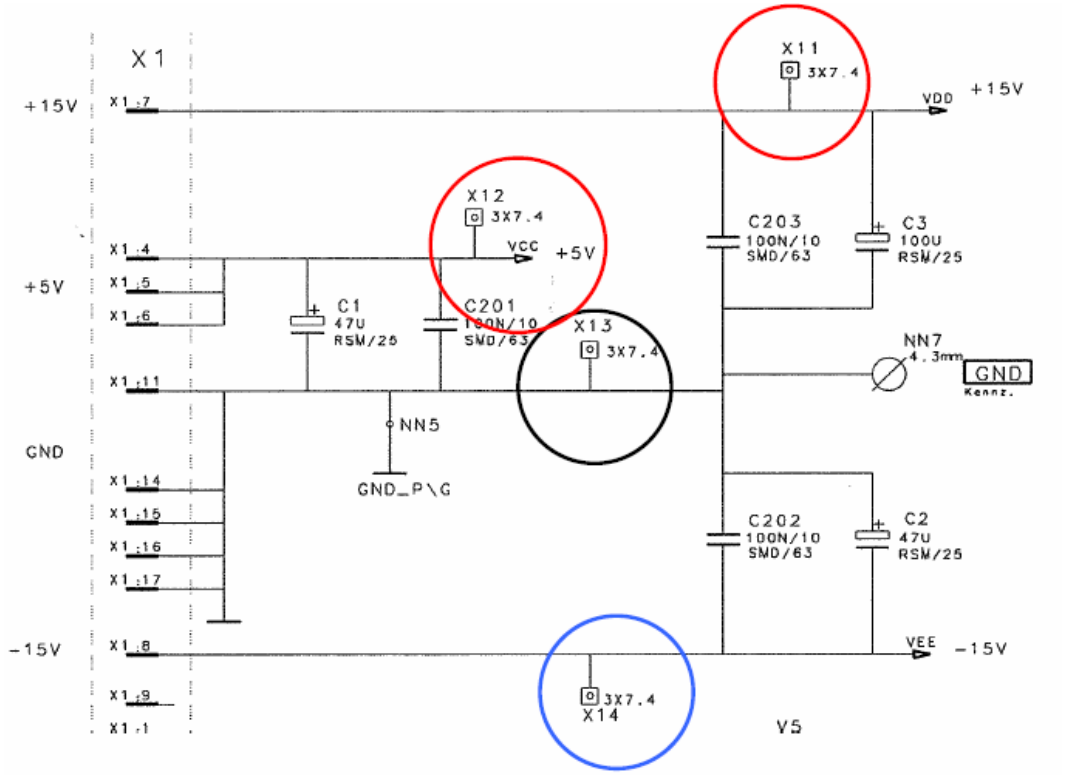
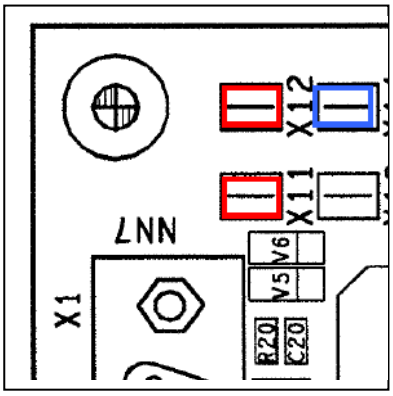
1) Check whether the supply from the EZ backplane or from the *Cube* is present:

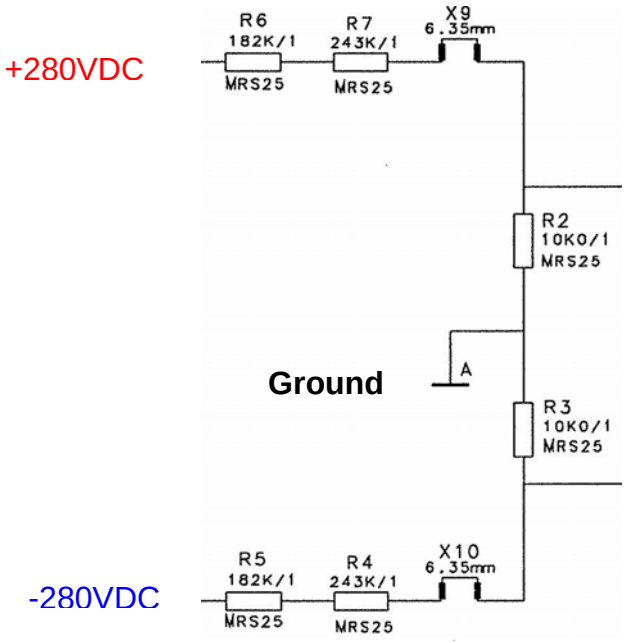
Location of resistors on Y100 PCB:

2) Check whether the voltage divider resistors are ok:
